# TECHNICAL PROPERTY INSPECTION REPORT

Pre-purchase inspection | Apartment | Tbilisi, Georgia

| PROPERTY | INSPECTION DATE | INSPECTION TYPE | FLOOR AREA |
|---|---|---|---|
| <b>Sample Residence<br/>Apartment 12</b> | <b>31 July 2026</b> | <b>Pre-purchase</b> | <b>82 sq. m.</b> |

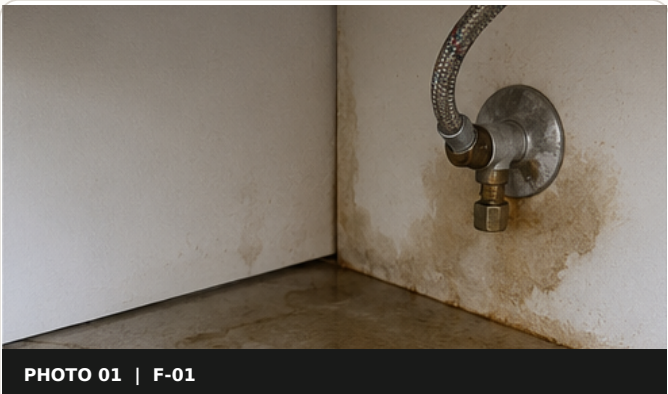
PHOTO 01 | F-01

| ID | LOCATION | OBSERVED CONDITION | SEVERITY | ACTION |
|---|---|---|---|---|
| F-01 | Main bathroom | Active slow leak and elevated moisture below vanity | MAJOR | Repair within 48 hours |

| Check | Result / Reading | Status |
|---|---|---|
| Visible leaks and seals | Slow leak at vanity flexible hose connection. | MAJOR |

| <div><div>F-01 Active leak and elevated moisture</div><div>Main bathroom Below vanity</div><div><div>OBSERVATION</div><div>Slow seepage observed at the flexible hose connection. Moisture screening recorded 24.8% WME at the adjacent cabinet back and wall finish.</div><div>EVIDENCE: Photos 01 and 06 PRIORITY: 0-48 hours REINSPECTION: Required</div></div><div><div>REQUIRED ACTION</div><div>Isolate the local supply if leakage increases. Licensed plumber to replace or reseal the connector, dry the area and check the cabinet and wall after drying.</div></div></div> | MAJOR |

**Leak below bathroom vanity**  
Damp staining around the hose connection and cabinet base.

| WHEN | ACTION | OWNER | CLOSE-OUT EVIDENCE |
|---|---|---|---|
| 0-48 hours | Repair F-01 bathroom leak and dry affected area | Seller / developer | Invoice, repair photos, moisture recheck |

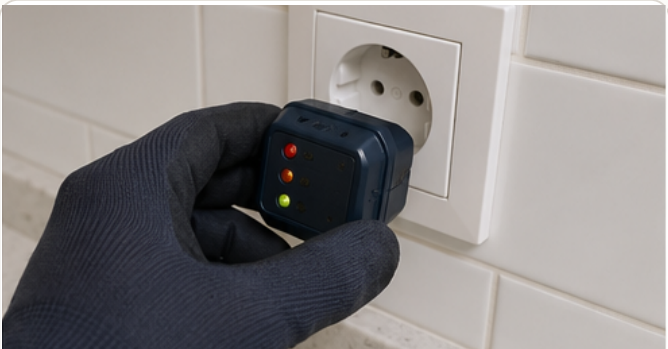
PHOTO 02 | F-02

| ID | LOCATION | OBSERVED CONDITION | SEVERITY | ACTION |
|---|---|---|---|---|
| F-02 | Kitchen | Earth continuity failed at two wall outlets | MAJOR | Electrician before occupancy |

| Check | Result / Reading | Status |
|---|---|---|
| Sockets and earth continuity | Two kitchen outlets failed earth continuity test. | MAJOR |

| <div><div>F-02 Earth continuity failed at two outlets</div><div>Kitchen Countertop outlets</div><div><div>OBSERVATION</div><div>Two sampled outlets energized normally but failed the socket tester's earth continuity indication. Supply voltage ranged from 228 to 231 V.</div><div>EVIDENCE: Photo 02 PRIORITY: Before occupancy REINSPECTION: Required</div></div><div><div>REQUIRED ACTION</div><div>Licensed electrician to test the circuit, confirm protective conductor continuity, repair the fault and issue written confirmation before occupancy.</div></div></div> | MAJOR |

**Kitchen outlet test**  
Two sampled outlets indicated loss of earth continuity.

| WHEN | ACTION | OWNER | CLOSE-OUT EVIDENCE |
|---|---|---|---|
| Before occupancy | Diagnose and repair F-02 earth continuity fault | Licensed electrician | Test result and reinspection |

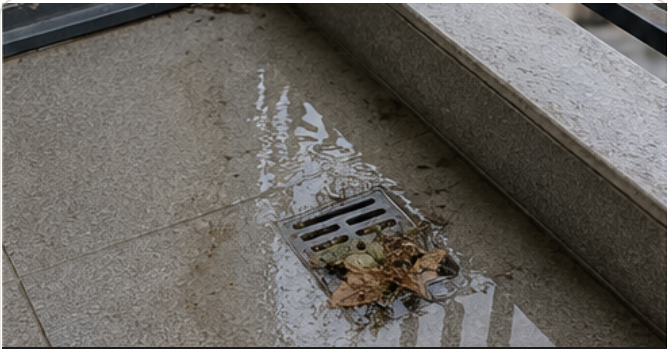
PHOTO 03 | F-03

| ID | LOCATION | OBSERVED CONDITION | SEVERITY | ACTION |
|---|---|---|---|---|
| F-03 | Balcony | Drain partially blocked with local ponding | MODERATE | Clear and water-test |

| Check | Result / Reading | Status |
|---|---|---|
| Balcony surface and drainage | Local ponding around partially blocked drain. | MODERATE |

| <div><div>F-03 Balcony drain obstruction and ponding</div><div>Living room balcony Drain corner</div><div><div>OBSERVATION</div><div>Leaves and construction residue partly obstruct the outlet. Shallow water remained around the drain and close to the door threshold.</div><div>EVIDENCE: Photo 03 PRIORITY: Within 7 days REINSPECTION: Recommended</div></div><div><div>REQUIRED ACTION</div><div>Clear the drain, flush the outlet and perform a controlled water test. Correct local falls or waterproofing if ponding persists after cleaning.</div></div></div> | MODERATE |

**Balcony drain and ponding**  
Debris at the outlet with water retained near the threshold.

| WHEN | ACTION | OWNER | CLOSE-OUT EVIDENCE |
|---|---|---|---|
| Within 7 days | Clear and water-test F-03 balcony drain | Seller / developer | Drainage video and no ponding |

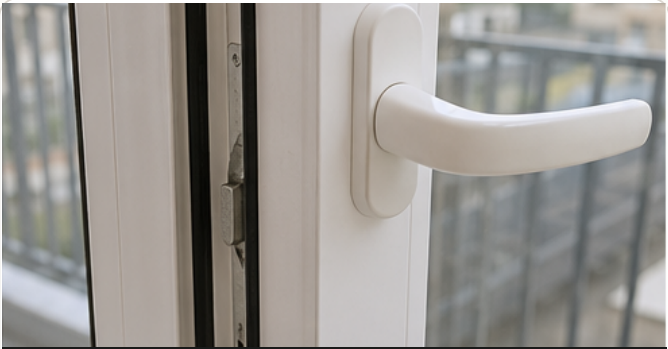
PHOTO 04 | F-04

| ID | LOCATION | OBSERVED CONDITION | SEVERITY | ACTION |
|---|---|---|---|---|
| F-04 | Living room | Balcony door seal gap and latch misalignment | MODERATE | Adjust hinges and latch |

| Check | Result / Reading | Status |
|---|---|---|
| Balcony door | Latch misaligned and seal compression gap present. | MODERATE |

| <div><div>F-04 Balcony door latch and seal misalignment</div><div>Living room Balcony door</div><div><div>OBSERVATION</div><div>The sash requires extra force to latch. A visible compression gap is present near the handle-side seal, increasing draft and water-entry risk.</div><div>EVIDENCE: Photo 04 PRIORITY: Within 14 days REINSPECTION: Recommended</div></div><div><div>REQUIRED ACTION</div><div>Adjust hinges and locking points, inspect the gasket and complete a perimeter water test after adjustment.</div></div></div> | MODERATE |

**Door seal gap**  
Handle-side sash alignment reduces gasket compression.

| WHEN | ACTION | OWNER | CLOSE-OUT EVIDENCE |
|---|---|---|---|
| Within 14 days | Adjust F-04 balcony door and inspect gasket | Window technician | Operation and water test |

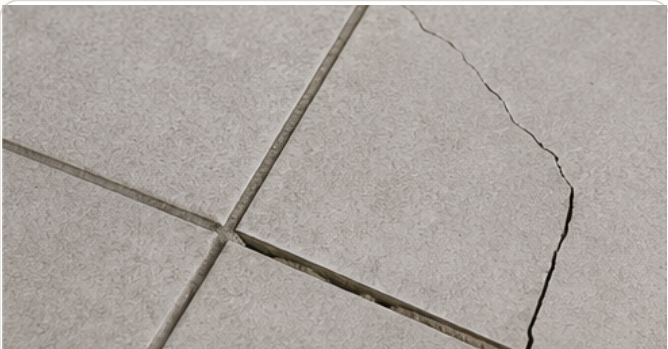
PHOTO 05 | F-05

| ID | LOCATION | OBSERVED CONDITION | SEVERITY | ACTION |
|---|---|---|---|---|
| F-05 | Main bathroom | One cracked floor tile and open grout joint | MINOR | Replace tile and reseal |

| Check | Result / Reading | Status |
|---|---|---|
| Floor finishes | One cracked bathroom tile and open grout joint. | MINOR |

| <div><div>F-05 Cracked tile and open grout joint</div><div>Main bathroom Floor beside vanity</div><div><div>OBSERVATION</div><div>One tile has a surface crack extending from the grout junction. The adjacent grout joint is locally open.</div><div>EVIDENCE: Photo 05 PRIORITY: Within 30 days REINSPECTION: Optional</div></div><div><div>REQUIRED ACTION</div><div>Replace the damaged tile, renew grout and inspect the substrate during removal for movement or moisture impact.</div></div></div> | MINOR |

**Cracked floor tile**  
Surface crack extends from an open grout junction.

| WHEN | ACTION | OWNER | CLOSE-OUT EVIDENCE |
|---|---|---|---|
| Within 30 days | Replace and reseal F-05 bathroom tile | Tiling contractor | Completion photos |

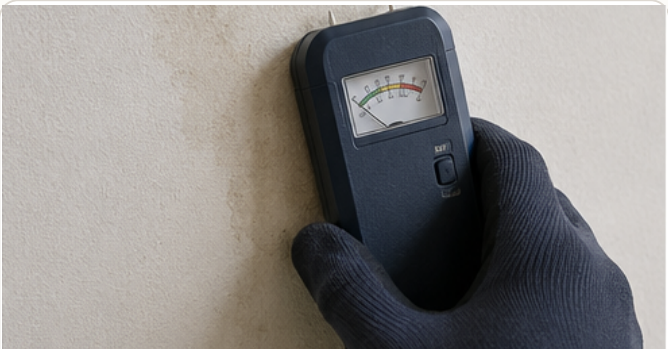
PHOTO 06 | F-01

| Check | Result / Reading | Status |
|---|---|---|
| Moisture screening | 24.8% WME below bathroom vanity. Other sampled walls normal. | MAJOR |

**Moisture screening**  
Elevated reading recorded beside the active leak area.

| PARAMETER | LOCATION | READING | ASSESSMENT |
|---|---|---|---|
| Moisture screening | Bathroom vanity wall | 24.8% WME | Elevated |
